## **Power Plant in Central KS – Field Services – Feed Rate Capacity and Compliance Issues**

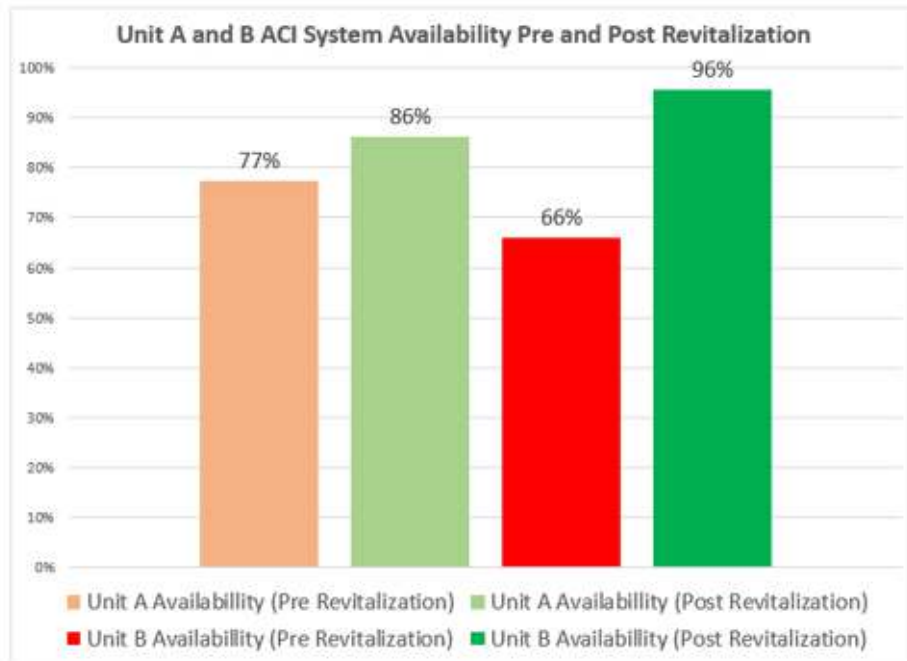
## REVITALIZATION RESULTS

Based on this information, the first step taken by the Motus representative was to feed all the Powdered Activated Carbon (PAC) out of the hoppers. While emptying the hoppers it was determined that the maximum achievable feed rate was approximately 250-300 lbs/hr, while the feeder's maximum feed rate was listed at 600 lbs/hr. While the hoppers were empty, the feeder scales (used to calculate the feed rate via loss in weight) were calibrated in order to rule them out as a potential source of inaccuracy. After the scales were calibrated and ruled out as the cause of the feed rate discrepancy, it was discovered that the screw flights were worn, and there was a substantial amount of PAC buildup in the flights.

The graph above represents the feed rate increase (availability) after preventative maintenance activities were performed by Motus Group during the site visit. PI data, provided by the customer from before and after the site visit, comparing feed rates at 100% VFD output (60 Hz) was used to create a direct comparison in top end performance capabilities.

**Resolution:** The screws were removed, cleaned, and put back in service so that the hoppers could be filled again. Feed rate testing after the hoppers were refilled resulted in feed rates in the range of 450 lbs/hr for one unit, and 550 lbs/hr on the other. The screw feeders' throughput (availability) increase is represented graphically below, and was based on PI data provided by the customer before and after the site visit activities were performed.

While it wasn't possible to achieve the maximum design feed rate, due to screw deterioration and reduced throughput capacity, the increase in feed rate was substantial, and helped the customer meet their compliance limit. Motus Group provided new screws and feeder seals to the plant, and recommended that the screw feeder hoppers be emptied out completely when downtime was expected to be two (2) weeks or more (to extend the life of the feeding equipment). This recommendation was provided as part of a comprehensive preventative maintenance plan created by Motus Group to help the customer avoid similar issues in the future.
